RAILROAD CROSSING SURFACE MATERIAL PERFORMANCE

Problem Statement:

The State of Michigan has large number of crossings with each type of surface, but there is a limited understanding on how each type has performed over time. Understanding performance over time is important, so that the most economical decisions can be made when determining crossing rehabilitations, or selecting materials for new crossings. Estimated Project Duration: Jan - Dec, 2013

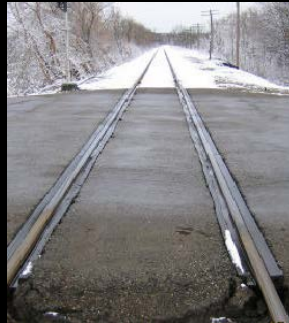
Crossing Before Reconstruction

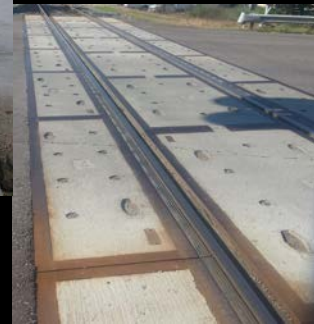
Crossing After Reconstruction

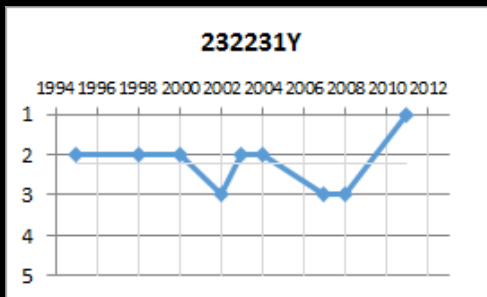
Graph of Ratings vs Time
